**GEIST STORAGE DAM  
(SPRINGTOWN RESERVOIR)**

**PHASE I INSPECTION REPORT  
NATIONAL DAM SAFETY PROGRAM**

GEIST (CRUM CREEK) STORAGE DAM  
DELAWARE COUNTY, PENNSYLVANIA  
(NATIONAL I.D. NO. PA-00348)

11 May 1978

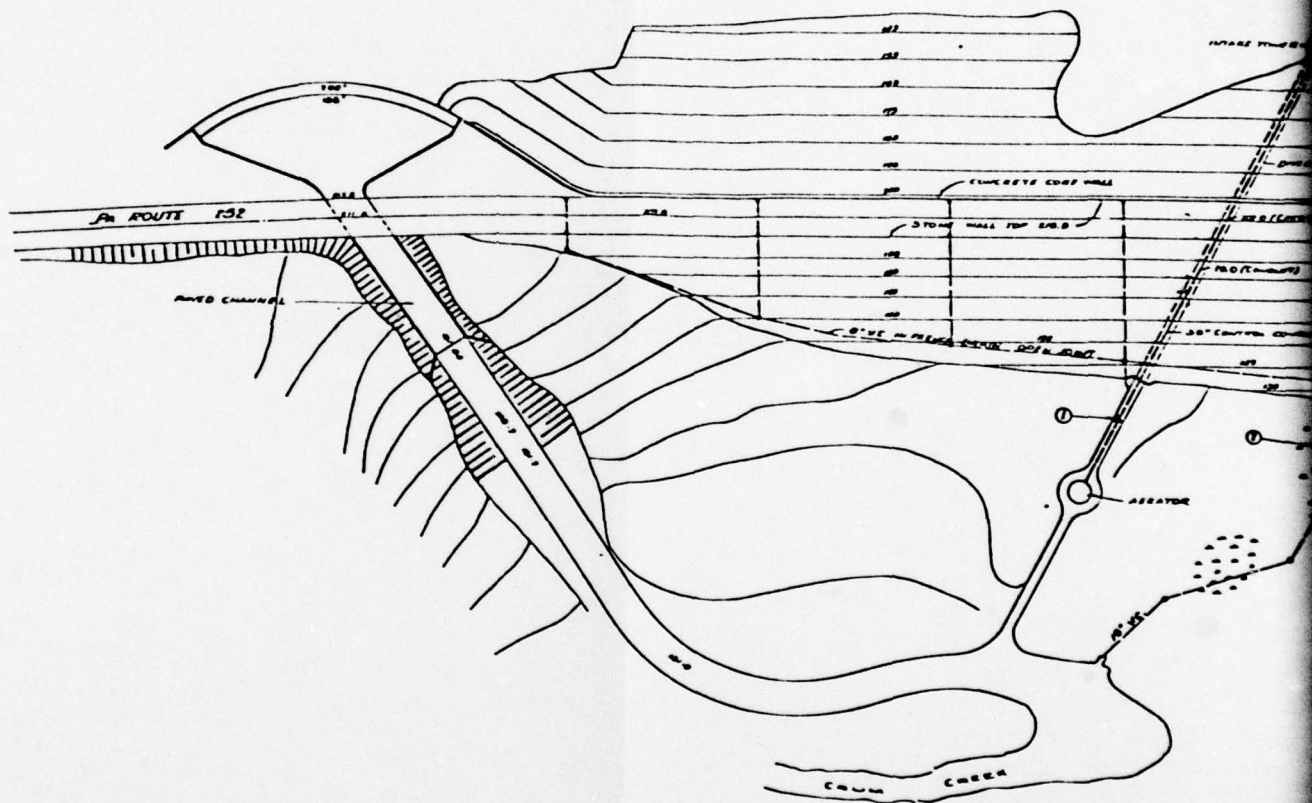
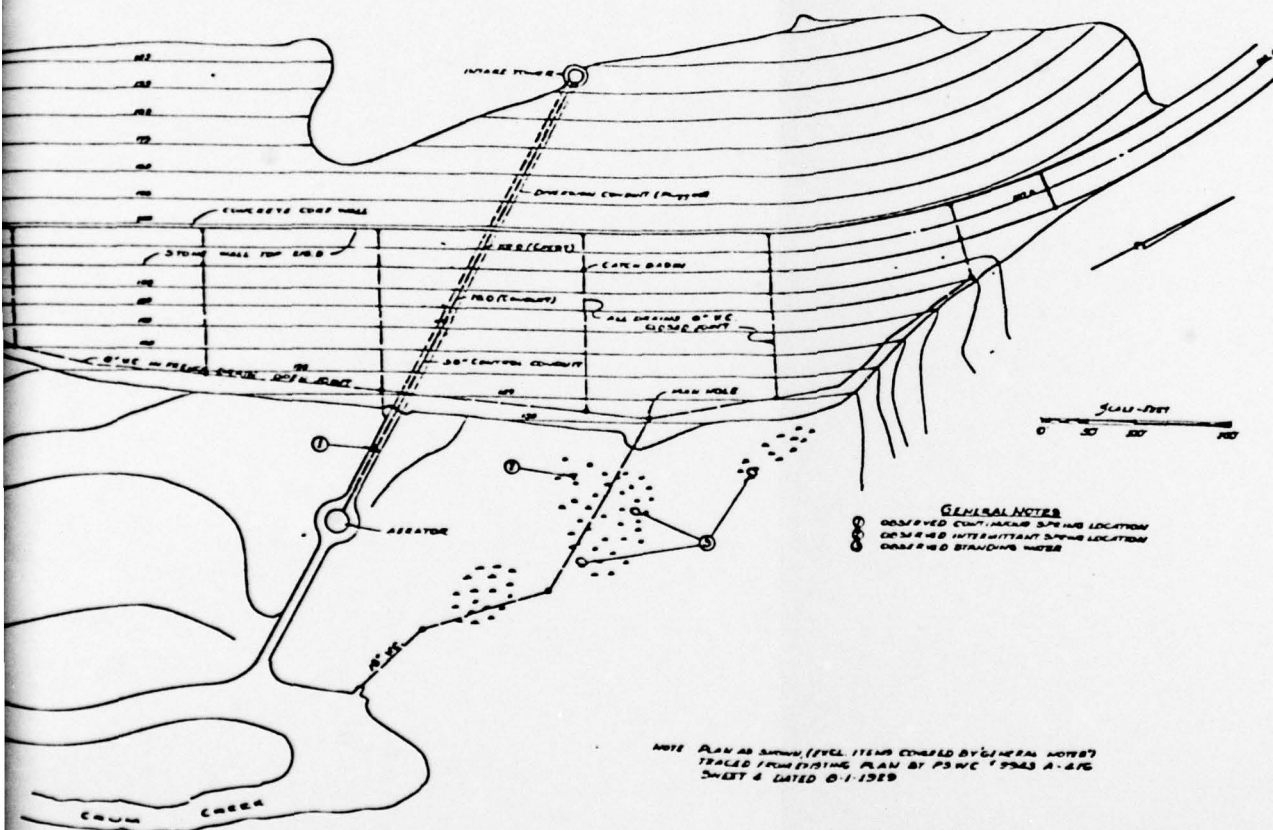
## SEEPAGE LOCATION PLAN

The survey failed to detect any evidence of distortions in alignment or grade which would be indicative of movement of the embankment or foundation. A careful inspection of the downstream slope and ground surface was conducted to observe any evidence of seepage emergence on or beneath the dam. Because of the porous rock fill mantling the downstream slope, no evidence of seepage was detected on this slope. However, small, clear-running springs were detected at two downstream locations during the inspection. It is understood that the Owner will be installing piezometers near the downstream toe to enable long-term observation of piezometric levels in the areas where there is existing seepage. The location of the springs are shown on Plate 3 and have been identified by previous inspections during 1972-73.
